**SAS Superstructure**

**Daily Diary Report by Bid Item**

Contract No.: 04-0120F4

Diary #: 941 Const Calendar Day: 485 Date: 02-Oct-2013 Wednesday

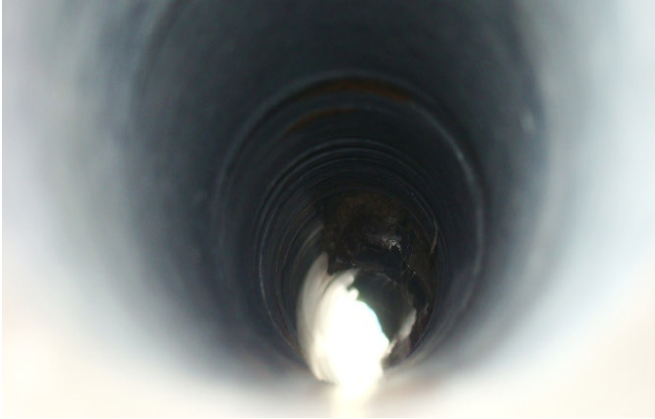
Today ABF engineer Adam Reeve noticed that when anchor rods S1D7 and S1D8 were cut and pushed down into the E2 Cap Beam that the rod was cored through back in May. ABF ironworkers spent most of the day trying to resolve fixing this issue as the cored anchor rod presents sharp edges which can shear PT strands. See photos below for more details on this issue. It should also be noted that per RFI#3492R00, ABF started to remove the entire anchor rod S1E2 that was thought to be broken due to stressing. When it was discovered that the rod was cored through, direction was given by TY-Lin to stop extracting the rod if it cleared the cored holes.

Cored section of anchor rod S1E8 seen from the west side of the E2 cap beam in a through tendon looking east.

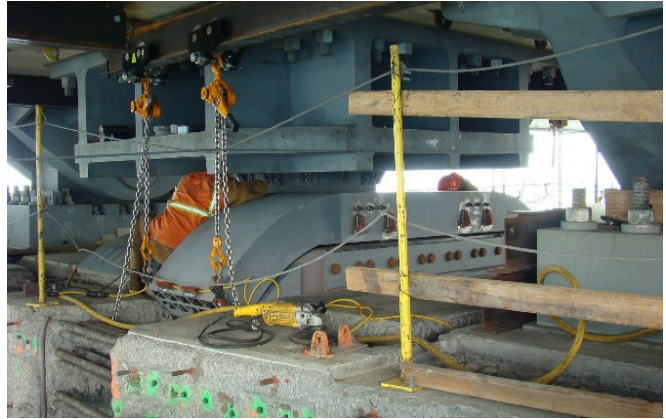
Other items to note were that dye grinding on the S2 Inboard Upper Saddle stub plate holes continued today as well. Conco laborers finished forming the grout pad blockout for the S1 SE Lower Saddle segment. Grout can't be placed at this time due to the fact that the forms didn't pass the "soak" test. Essentially the forms need to hold water and not leak for 24 hrs prior to grout placement per Submittal #2914R00.

ABF ironworkers cutting anchor rods and dye grinding the S2 Upper Inboard Saddle stub plate holes.

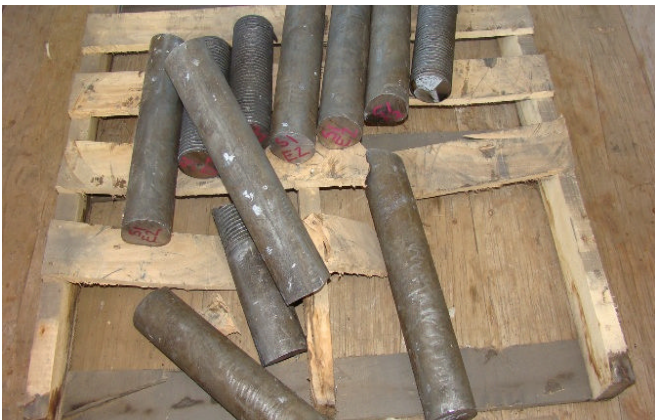
Cut anchor rods today put into a box to be shipped back to Pier 7 for additional testing.

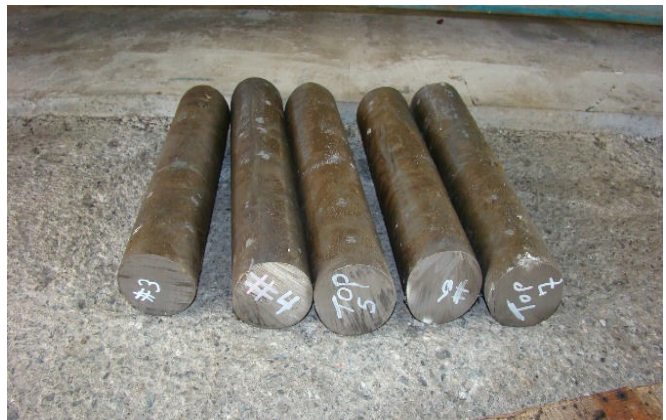
Cut sections of anchor rod S1E2 removed from the blackout.

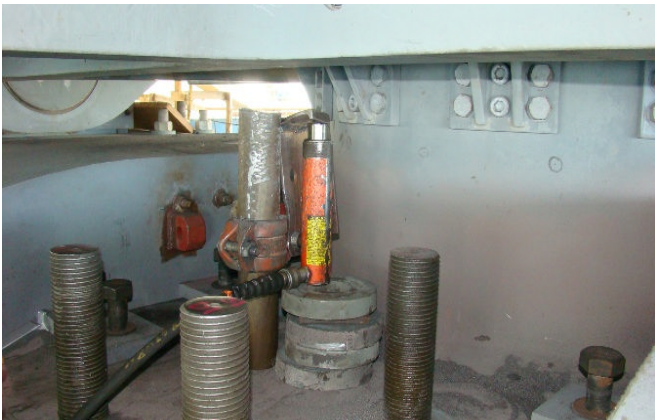
Jacking setup to extract anchor rod S1E2 from the blackout looking west.

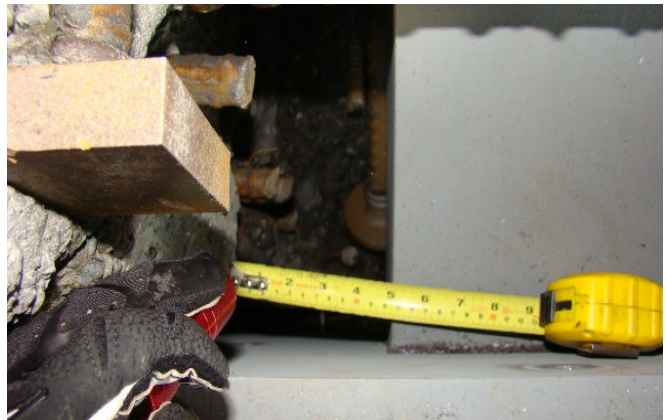
Gap of 5" measured between the demo concrete and the S1 SE Lower saddle segment for grouting.

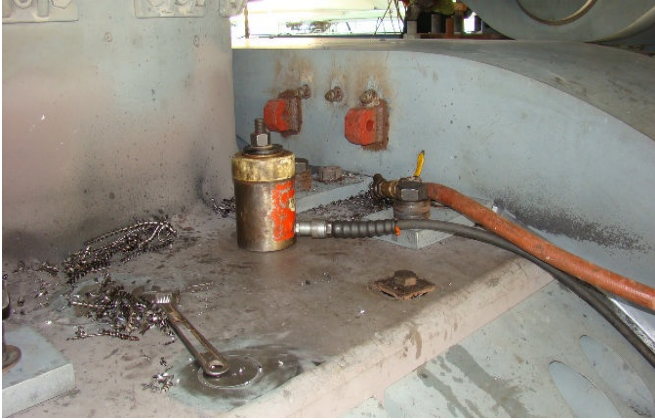
Jacking removal system for removing the S1E7 and S1E8 anchor rods looking SE.
